# **INDOOR AIR QUALITY ASSESSMENT**

**Archie T. Morrison Elementary School  
15 Mayflower Road  
Braintree, Massachusetts**

Prepared by:  
Massachusetts Department of Public Health  
Bureau of Environmental Health Assessment  
February, 2001

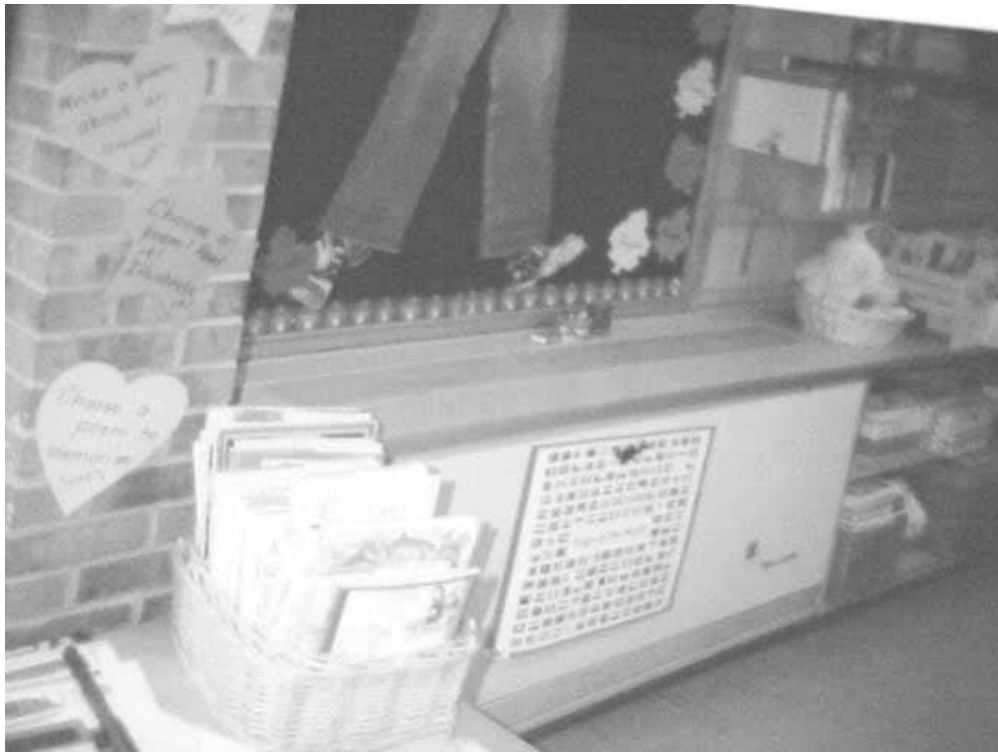
**Picture 1**

It can be seen from the tables that carbon dioxide levels were elevated above 800 parts per million parts of air (ppm) in twenty of twenty-nine areas surveyed, which indicates inadequate air exchange in a number of areas in the school. Fresh air in classrooms is supplied by a unit ventilator (univent) system (see Picture 1). Univents draw air from outdoors through a fresh air intake located on the exterior walls of the building (see Picture 2) and return air through an air intake located at the base of each unit ([see Figure 1](#)). Fresh air and return air are mixed, filtered, heated and provided to classrooms through a fresh air diffuser located in the top of the unit. All univents were operable. However, univents appeared to be original equipment, which would make them approximately thirty-two years old.

Several univents were deactivated. The univent in classroom 202 was deactivated due to noise from the radiator system, which may indicate a leak in the system. Obstructions to airflow, such as items placed in front of univent returns, were seen in a few classrooms. To function as designed, univents and univent returns must remain free of obstructions. Importantly, these units must be activated and allowed to operate during hours of school occupation.

**Classroom Univent**

8. Remove all blockages from univents and exhaust vents to ensure adequate airflow. Close classroom hallway doors to maximize exhaust ventilation.
9. Repair and/or replace thermostats and pneumatic controls as necessary to maintain control of thermal comfort.

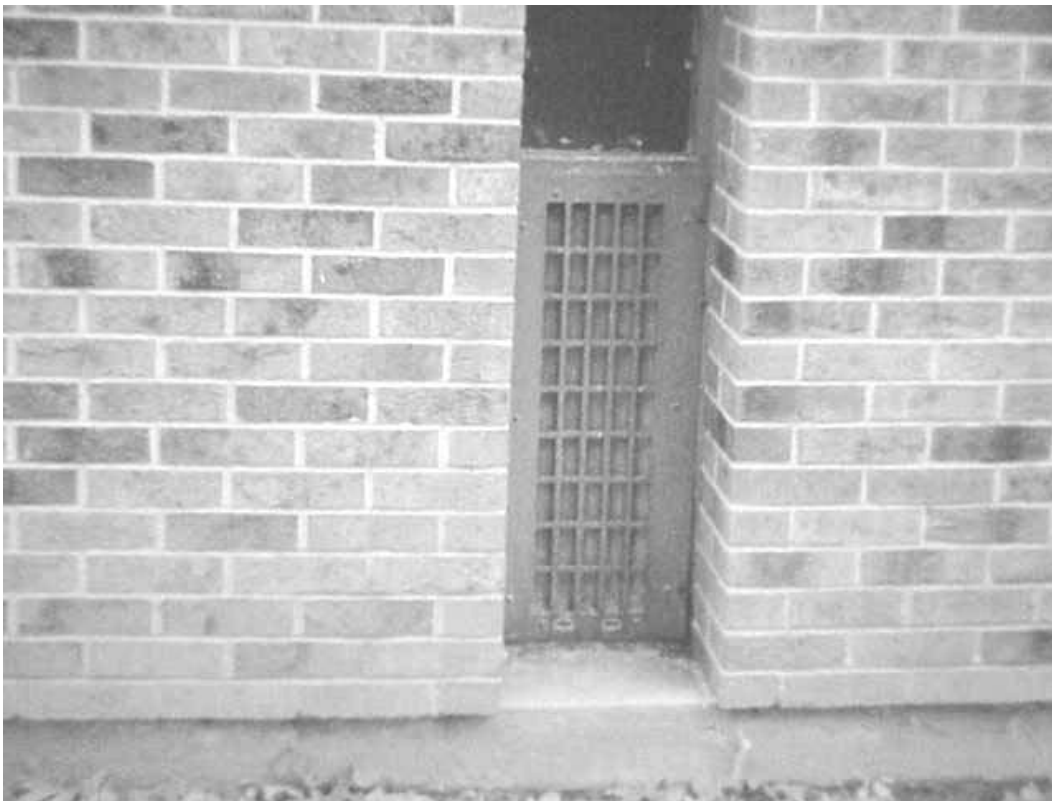
**Picture 2**

**Univent Fresh Air Intake**

1. Continue with preventive maintenance plan for HVAC equipment. Check fresh air intakes for repair, an increase of the percentage of fresh air intake may be necessary. Consider consulting a heating, ventilation and air conditioning (HVAC) engineer concerning the calibration of univent fresh air control dampers school-wide.

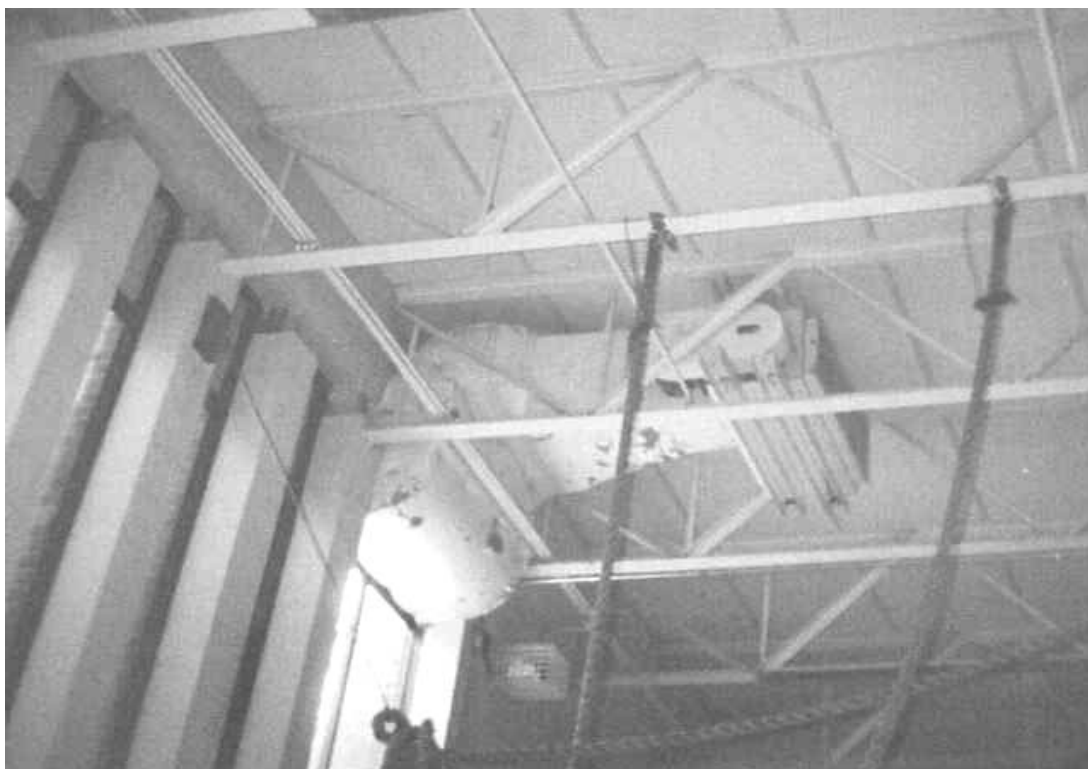
**Picture 5**

Ventilation for the gymnasium was originally provided by two ceiling-mounted AHUs which drew air from outdoors through fresh air intakes located on the exterior walls of the building (see Picture 5). These units were not operating during the assessment, and it could not be confirmed by school officials as to whether these units were still functional.

**One of Two Inactive AHU's in Gymnasium**

6. Examine AHUs in the gymnasium and operate if functional. If not functional, examine the feasibility of repairing/replacing units to provide fresh outside air.

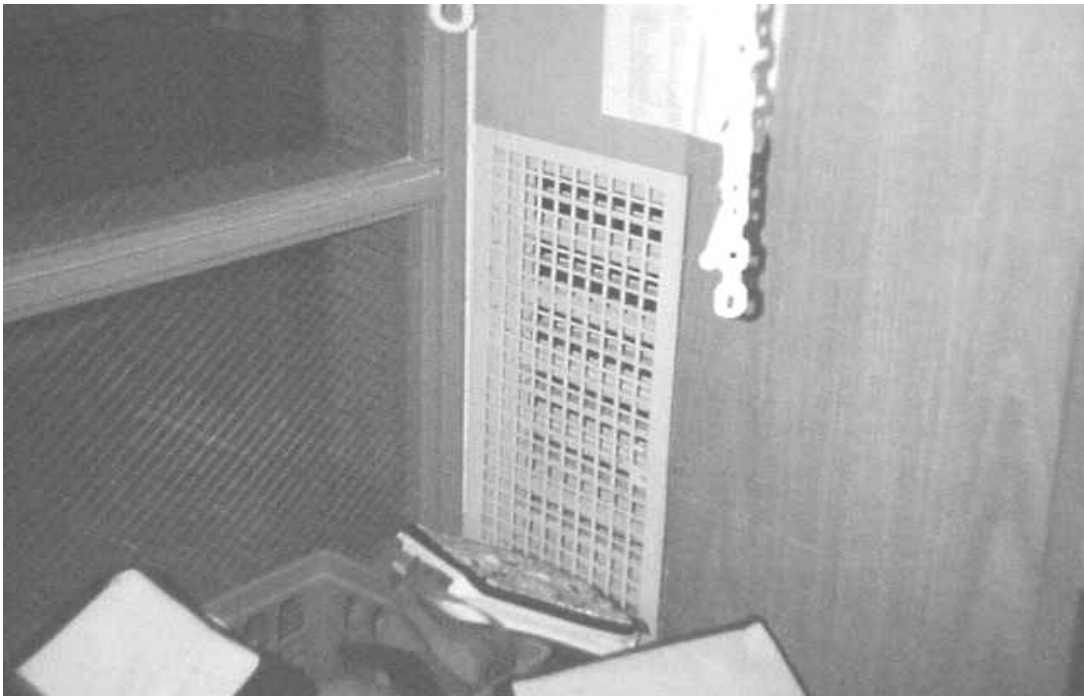
**Picture 7**

The mechanical exhaust ventilation system in classrooms consists of grated, wall-mounted exhaust vents (see Picture 7), a number of which were drawing weakly (see Tables). Exhaust vents from individual classrooms are drawn into a common duct above the ceiling in the hallway to be expelled from the building via rooftop motors (see Picture 8). A number of exhaust vents were obstructed by tables, chairs, boxes and other items (see Picture 9). The location of exhaust vents can also limit exhaust efficiency when the

**Example of Wall Mounted Exhaust Vent**

2. Consult with an HVAC engineer as to whether exhaust ventilation for classrooms can be increased.
3. Determine if the AHU supplying the computer room and library is provided with outside air. If not, consider ducting to the outside to provide fresh air.

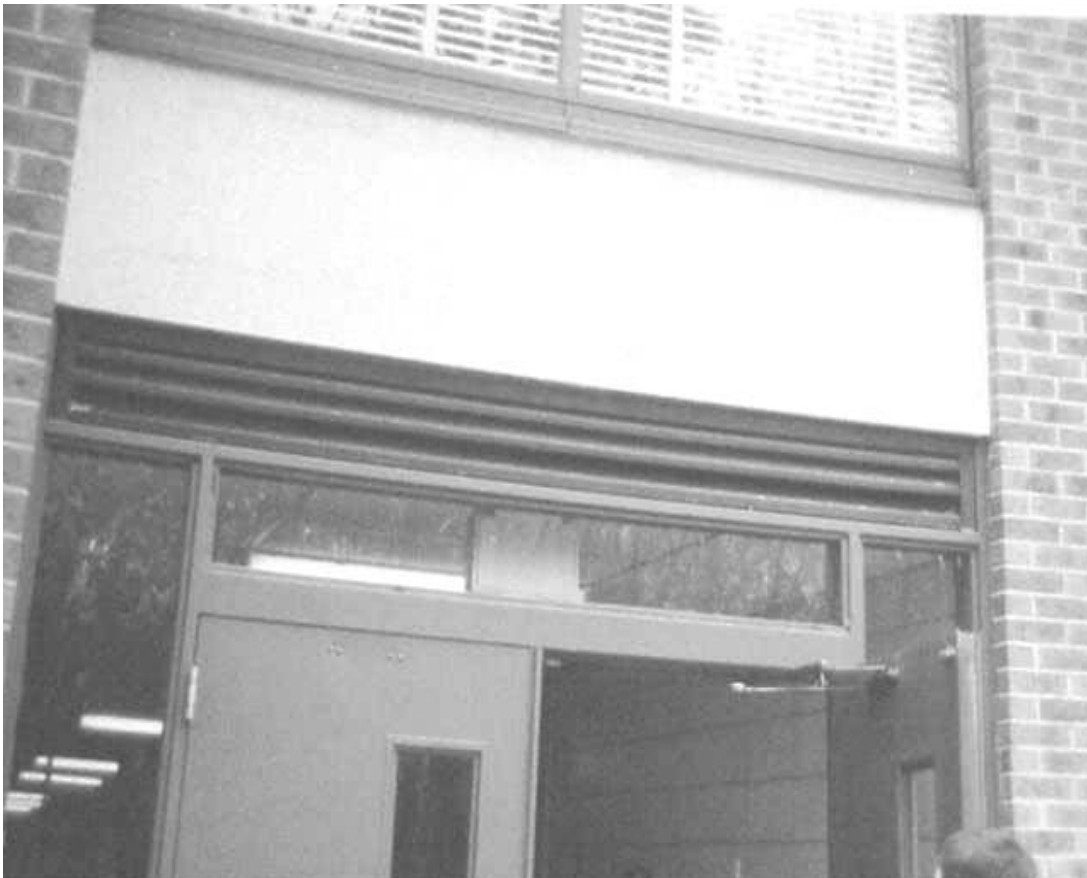
**Picture 8**

**Common Hallway Exhaust Vent**

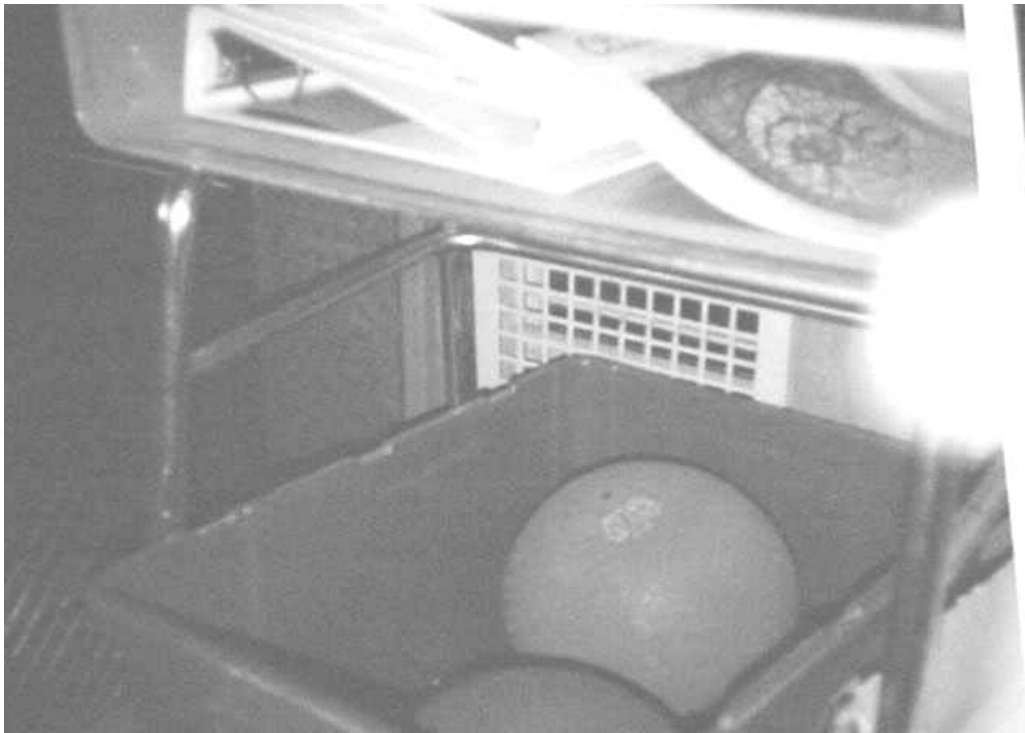
**Picture 9**

classroom hallway door is open. When a classroom door is open, exhaust vents will tend to draw air from both the hallway and the classroom. The open hallway door reduces the effectiveness of the exhaust vent to remove common environmental pollutants from classrooms. Without removal by the exhaust ventilation, normally occurring environmental pollutants can build up and lead to indoor air complaints.

**Obstructed Classroom Exhaust Vent**

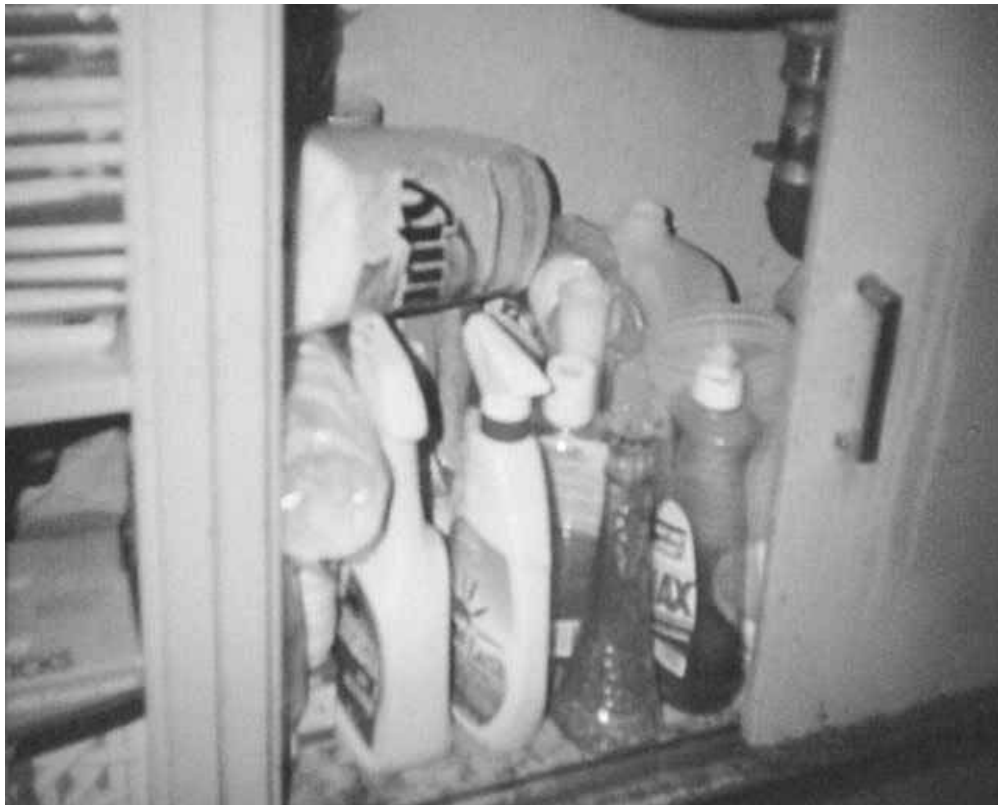
**Picture 10**

Cleaning products were found on counter tops and underneath sinks in a number of classrooms (see Picture 10). Cleaning products contain chemicals (such as bleach or ammonia-related compounds), which can be irritating to the eyes, nose and throat. These items should be stored properly and out of the reach of students.

**Cleaning Products in Cabinet under Sink**

13. Seal areas around sink in classrooms, to prevent water-damage to the interior of cabinets and adjacent wallboard. Inspect wallboard for water-damage and mold/mildew growth. Repair/replace as necessary. Disinfect areas of microbial growth with an appropriate antimicrobial as needed.
14. Clean chalkboards and trays regularly to prevent the build-up of excessive chalk dust.
15. Change filters in portable air purifiers as per the manufacturer's instructions to prevent the re-aerosolization of dirt, dust and particulate matter.
16. Store cleaning products and chemicals properly and keep out of reach of students.

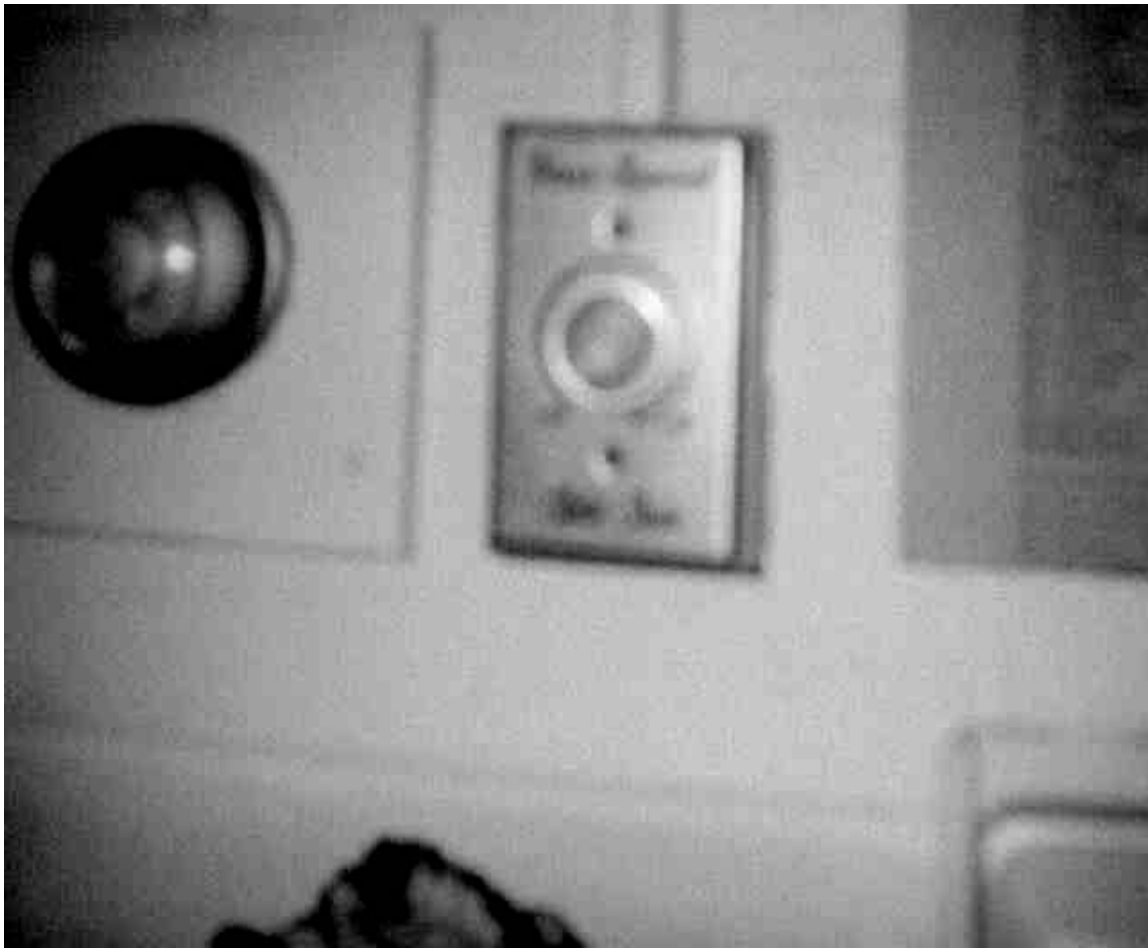
**Picture 11**

**Example of Variable Speed Control for Exhaust Fan**

5. Operate exhaust ventilation in cafeteria during lunch hours to circulate air, and to remove excess heat and odors. Consider installing a variable speed control to adjust fan speed (see Picture 11 for an example). Reconfiguration of cafeteria HVAC system may be necessary to avoid short-circuiting.
